## **RD98X – MAC ADDRESS BECOMES ALL ZEROS**

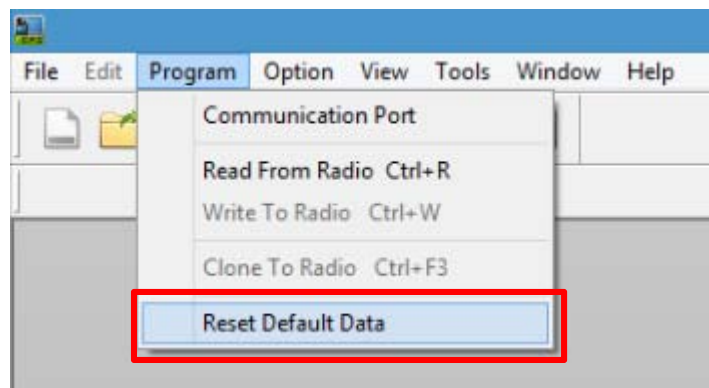
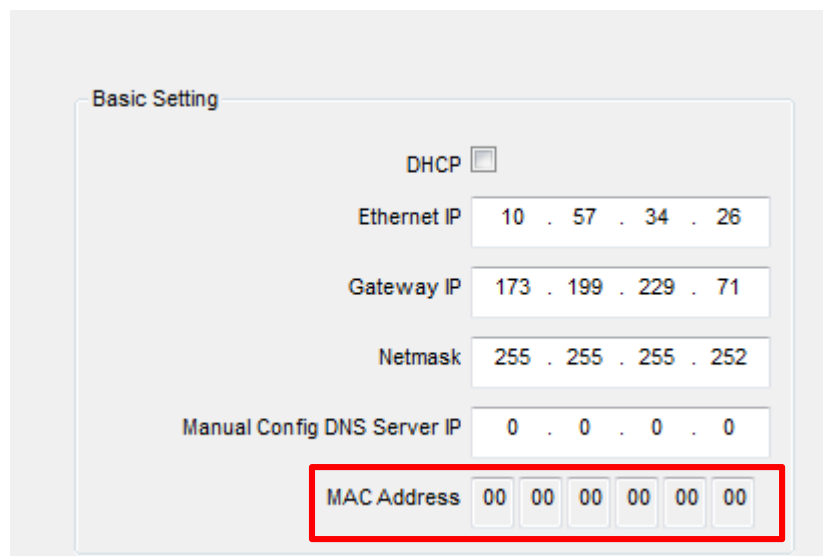
It has been observed in isolated cases that when using the feature, “Reset Default Data” using CPS version 5.05.14.002 this could inadvertently wipe the MAC address of the internal IP Network Adapter. Please avoid using this option. If you experience this issue you may contact Technical Support to have a software repair tool created which will re-write the previous MAC address to the RD98X. Please include the code plug showing the missing MAC address from the affected RD98X along with your request.
