Exploded View & Miscellaneous Parts

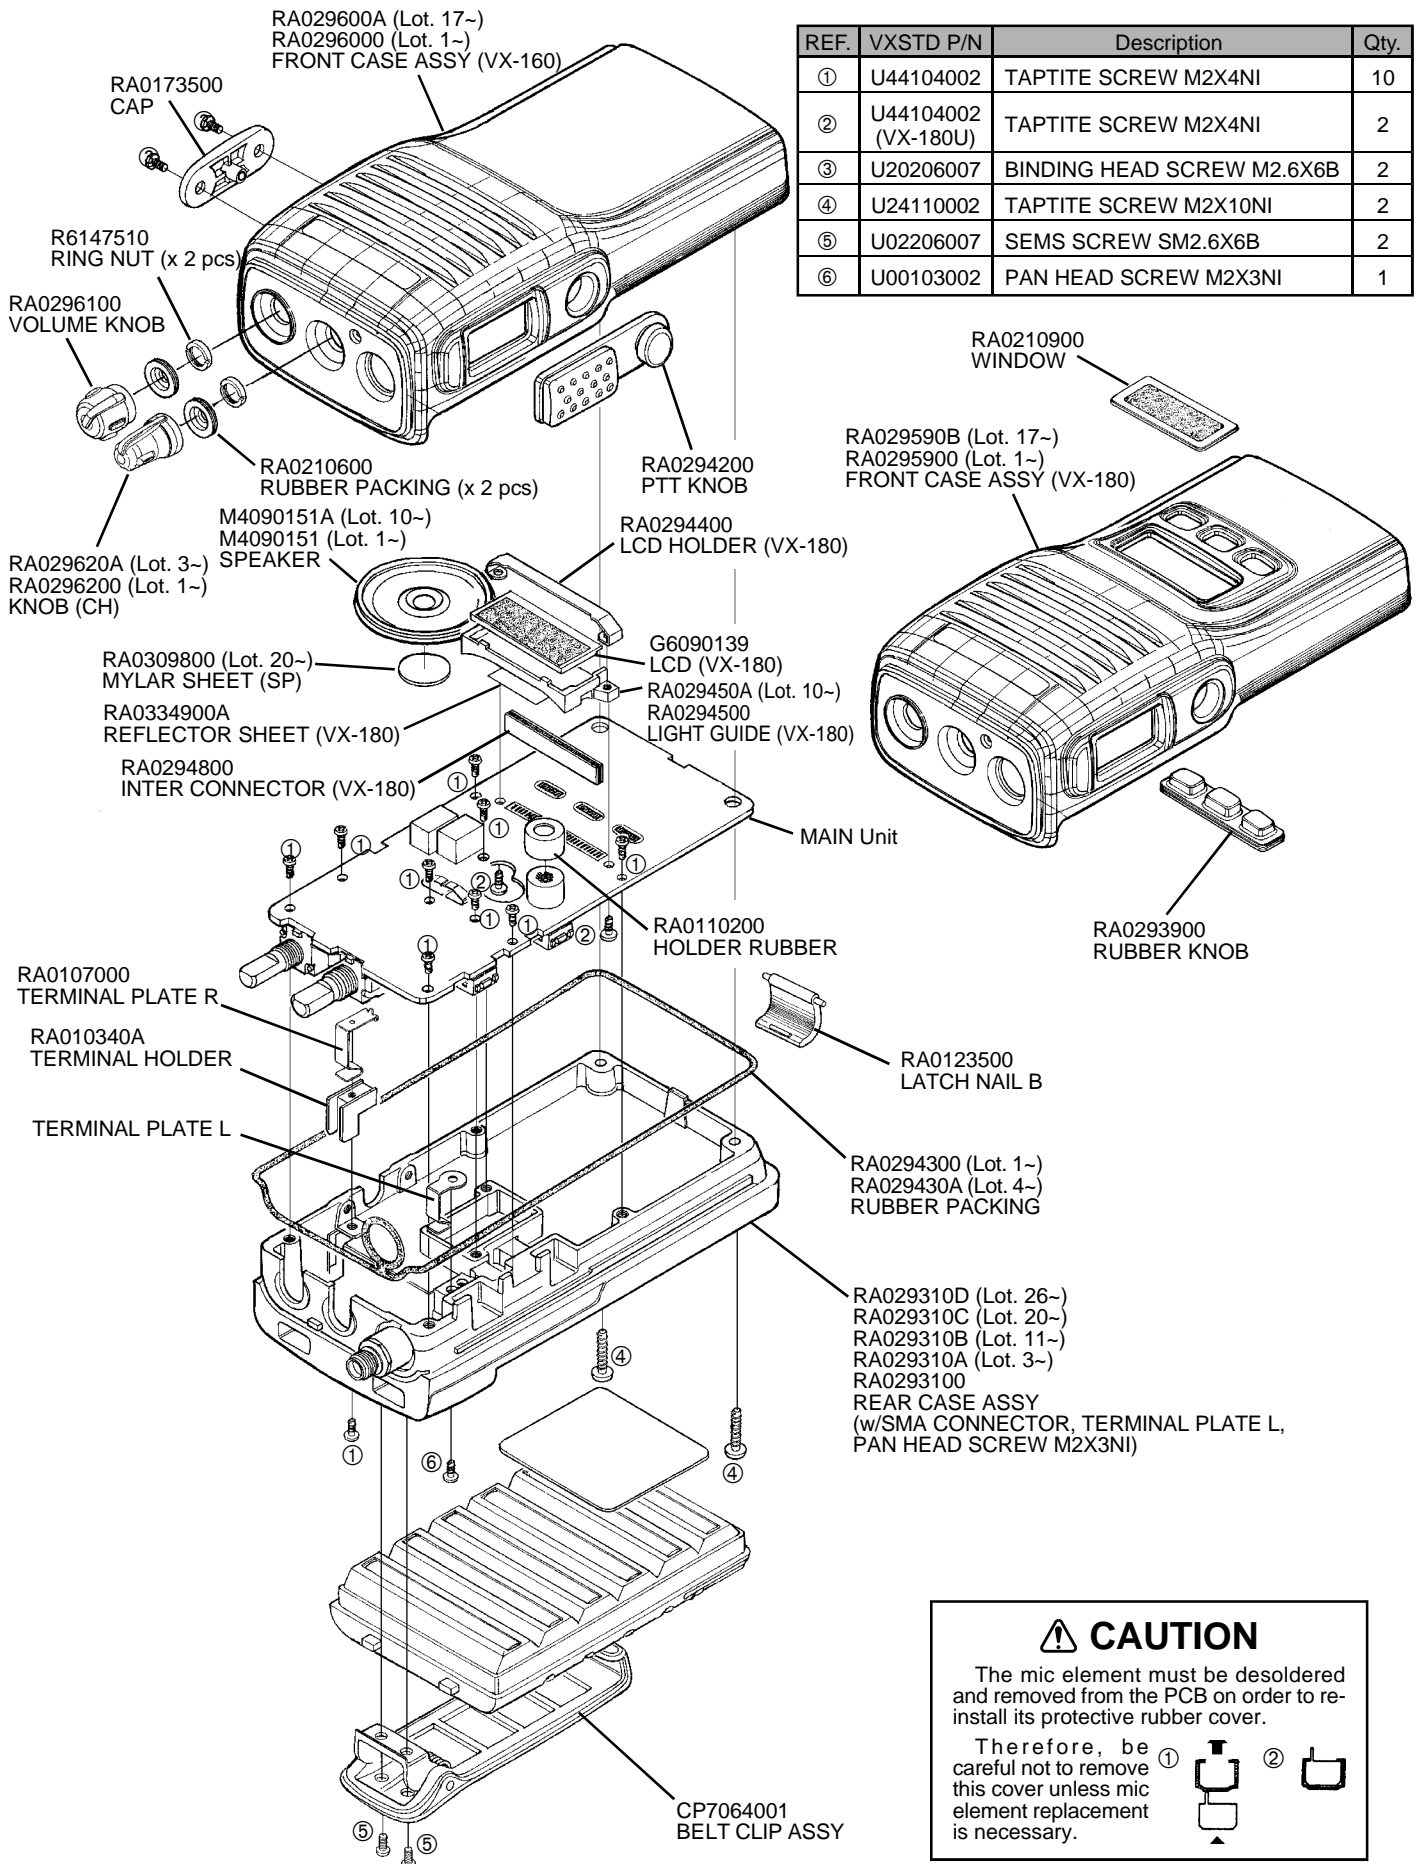
| REF. | VXSTD P/N | Description | Qty. |
| ① | U44104002 | TAPTITE SCREW M2X4NI | 10 |
| ② | U44104002 (VX-180U) | TAPTITE SCREW M2X4NI | 2 |
| ③ | U20206007 | BINDING HEAD SCREW M2.6X6B | 2 |
| ④ | U24110002 | TAPTITE SCREW M2X10NI | 2 |
| ⑤ | U02206007 | SEMS SCREW SM2.6X6B | 2 |
| ⑥ | U00103002 | PAN HEAD SCREW M2X3NI | 1 |

The mic element must be desoldered and removed from the PCB on order to re-install its protective rubber cover.

Therefore, be careful not to remove this cover unless mic element replacement is necessary.
